# Utilization of the Ultrasonic Diagnostic Method in Rail Status on a Defined Railway Section

**Abstract** – In the article we deal with the issue of non-destructive diagnostics of a specified part on the railway, namely the rail. The chapters are devoted to the non-destructive defectoscopic method, or more precisely an ultrasonic test, which is performed by DIO 562 device and it also includes data processing from the measurement. The article briefly describes location and character of defects on the rails and actual process of measurement. The measurement was performed on a standard length of 10 km, with the use of a device capable of copying shape of the rails during the ultrasonic examination. The evaluation of the measurement was processed in specialized software DIO 2000 on the PC. Based on this evaluation, three manual inspections were implemented to determine the character of defects. The conclusion of this article is a precise determination of character and origin of these selected defects, and suggestion for their removal or replacement according to the valid regulations.

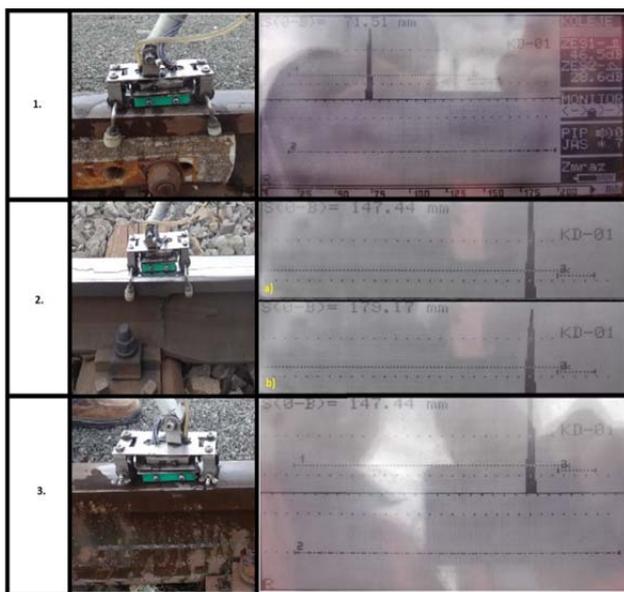
During the measurement, we encountered number of cases that were evaluated, based on echo reflections in the frozen record of the course of primary control, by the device as errors. Examples of these situations can be seen in Fig. 10. In its first part, we can see the echo caused by the hole in the clutch chamber, we can see the change in distance of the reflected signal, compared to the original height of the rail. The second part describes the transition from the "S" type to the "R" type. This change occurred when we were leaving the railway station, or more precisely the speed zone. As seen on the illustration a stronger echo from the lower rail profile "S" (2a) is clearly distinguished, on the lower scale after the R-type ramp (2b). In the third part, we can see a standard measurement of the rail height with a direct probe, which runs virtually during the entire part of the basic test.

Figure 10. Selected examples of individual obstacle evaluation during basic control

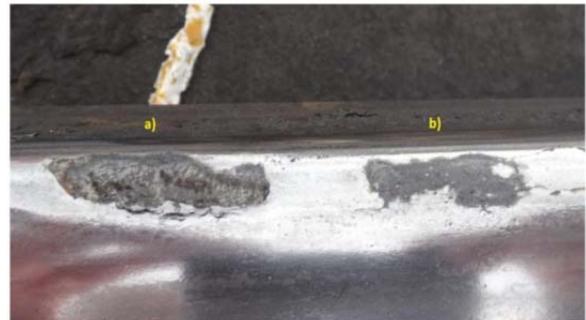
Material peeling from the rail's running edge– this error was located on the left-hand lane of the crosshairs marked 8a. The last change of the switch language at this section was in 2000 and is a classic S49 rail profile. The test was conducted with the DIO 562, but due to the technical design and the shape of the switch language, it was not possible to use a continuous control device. Error identification was performed using a 5MHz angular 70 ° probe at 35dB.

Figure 11. Measured part with defect (measured site a, b)

On the tongue of the crossing, a series of consecutive defects was found on a total length of 170 mm. In Fig. 11 we can see the details of two of these defects. On the basis of a detailed inspection carried out according to the regulations, we can read from the DIO 562 device that in the case of a) it is an error with depth  $h = 4.6$  mm and length  $l = 13.5$  mm, while in case b) relatively less damage with  $h = 0.3$  mm,  $l = 11.9$  mm. According to the valid regulations, on the basis of which this error was identified, it can be said that this type of damage occurs due to contact and sliding forces, which are created between the rail and the track vehicle.

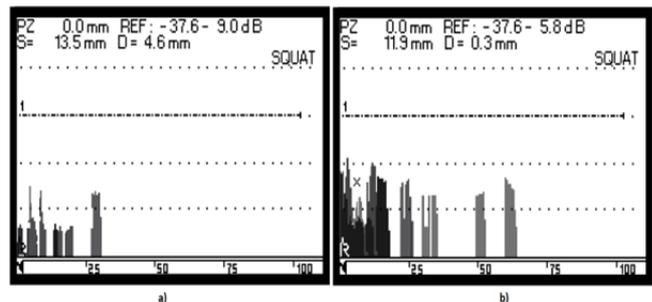
Figure 12. The results of the measured parts a, b

The designation "C" is characteristic of this type of error because the maximum depth of defect  $h = 10$  mm has not been exceeded, i.e. it is recommended to replace the rail (tongue or hedge) for the selected section or to repair the damaged section [2].

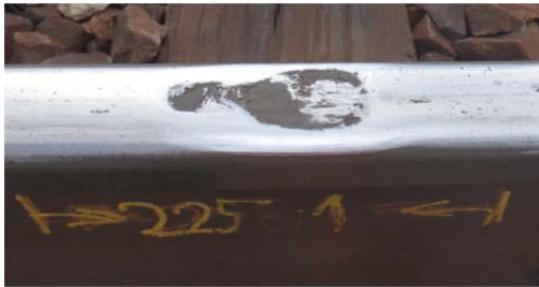
Figure 13. Detail of the measured part with damage 2251D

Damage caused by the slipping of the track-side vehicle – the damage shown in Figure 61 was located on the right straight of the track near the 2nd measured point. The last replacement of the rail was in 2002 and it was a R65 profile. Measurement was performed using a direct 3.5MHz probe and 32dB output. The extent of damage to the rail was 50 mm in length and its depth was measured by increasing the echo from the direct probe at the defect transition. The measurement results can be seen in Fig.14 where we can see a clear increase in UT signal echoes when passing through a lower cross section of the profile on the damaged site.

The designation "D" is characteristic of this type of defect. Since the maximum depth of defect which has not exceed the value of  $h = 6$  mm, we recommend increased observation rate for this section due to the possible development of the defect [4]. In this case, it is necessary to repair the sliding site, because of the possibility of its development.

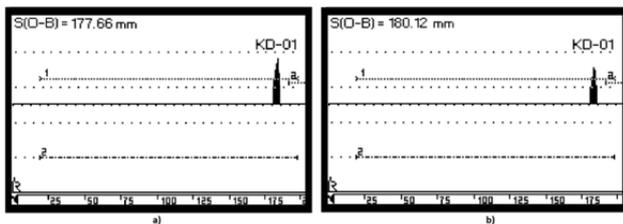
Figure 14. Measurement results of the slipping section (a) standard rail height in front of the damage site, (b) rail height at the point of damage)

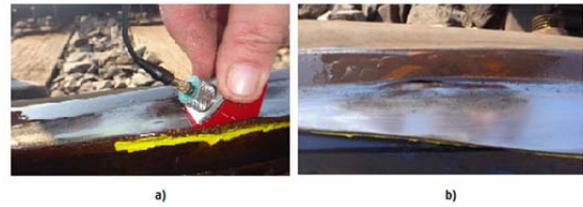
In a special case on the measured section a defect was detected by a visual check on railway crossing. The railway frog, which is the toughest part of the railway crossing construction, it is impossible to measure it with DIO 562 and the device used in the previous measurements, due to its shape and tenacity. The data are obtained directly by manual device with the use of angled probes. Due to the toughness of the frog, which often has to withstand a high impact load, an EPOCH device was used for this

Figure 15. Railway frog measurement (a. measurement with 70 ° probe, b. defect discovered during visual inspection)

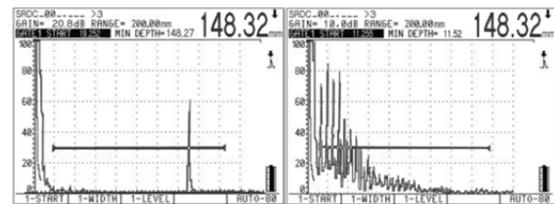
The last defect marked with the number 5122 was caused by the periodic bumping of the train wheels, which created an undercut. Since the defect was located on the railway frog, which is the toughest section of railway, ultrasound testing was relatively difficult. In these defects, the capillary method is prioritized. Nevertheless, after the ultrasonic equipment was exchanged and different probes used, it was possible to obtain necessary surface defect data. The one we could find is based on the ultrasonic measurement extends to a depth of 11.52 mm. It is located on the surface of the rail and its length does not exceed 32.41 mm. According to the valid statutes defining the repairs of railway frogs, the defect of this character and its range, it is recommended repair by thermal welding [1].

Figure 36. Results of measurement of cross section with damaged heart
