# Examination of Surface Quality after Drilling of Wood Plastic Composite

**Abstract** – Presented article with machining (specifically drilling technology) of composite materials is based on Wood-Plastic Composite, in short WPC (as a minimum substitute for wood in interior / exterior applications). Experiment is focusing on selected technological parameters of machining (spindle speed and tool feed rate) on the characteristics of created surface. Surface cut zone quality – surface topography is examined by contact profilometry (as commonly available methods) and optical methods. The results of the experiments point to the disadvantages of these composite materials and the basic aspects influencing the quality of surfaces after machining is the inhomogeneity of the material.

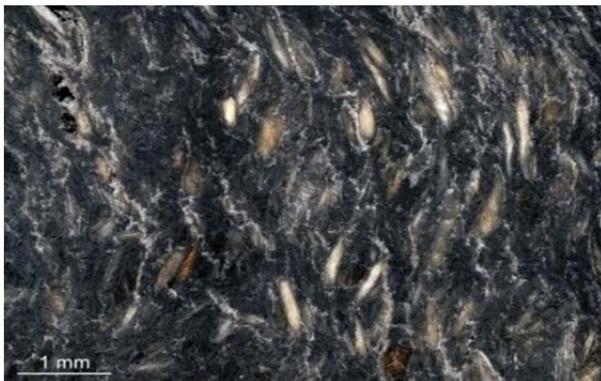
Figure 1. Examined material: Wood plastic Composite (Nikon Eclipse 80i) [13]

**Material:** Experimental material was wood filled plastics (commercially manufactured sample) – with PE matrix and wood reinforcement (unspecified) in ratio: 30/70 % (Figure 1). Experimental material exhibits: tensile strength  $R_m$  approximately 20 MPa (experimentally found), elongation  $A = 3.05$  %, contraction  $Z = 0.9$  % and deformation work is 17.6 mJ (experimentally obtained values are average values of set number of tested samples). Experimental material has relatively high life-time, ability to resist moisture /adverse weather/ pests and insects (when applied in extremely humid conditions, it is possible to apply resin from Guayele tree as a matrix, it is resistant to skidding (most of the characteristics are compared in relation to commonly available wood materials). **Application:** construction – building cladding, terraces / flooring – exterior flooring / furniture industry / automotive industry – dashboards, luggage compartment bottoms (Volvo), door upholstery, ceilings, luggage compartment components (Mercedes), etc.

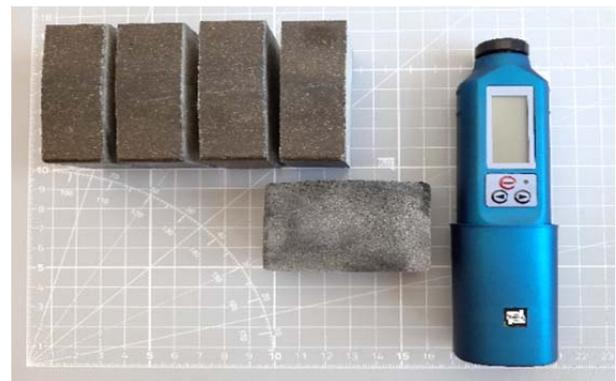
Figure 2. Evaluated samples (5 pieces, marked places of hardness measurement. In volume of extruded profile: 1-middle, 2-left side, 3-right side / 4-surface of extruded profile)

average values of the individual sites for the samples marked 1 to 5 are given in the Table 1.

There are obvious differences between the measured values in the individual areas. The hardness values at the edges of the examined profiles range from 195.2 to 299.7 HLD. In area 1, in the volume of the examined profile they are of the order of magnitude higher (323.4-368.4 HLD). On the surface of the extruded profile, they reach approx. 500 HLD (values can be seen in Table 1). Figure 4 shows the dispersion of values (11 measurements) in individual areas of the profile volume (for area 1 to 3).

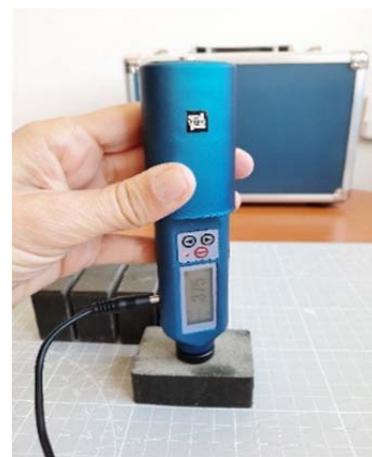
Figure 3. Principle of measurement in the middle of sample (in place 1)

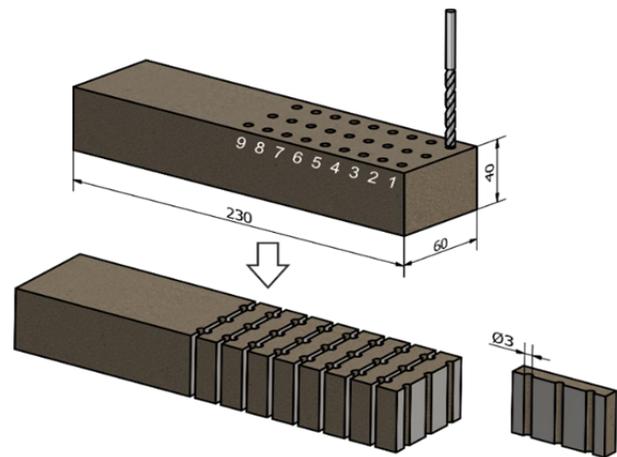
Figure 5. Methodology of sample preparation (before the measuring of surface roughness)

For experimental evaluation (drilling technology), a workpiece with the following dimensions was selected: 60 x 40 x 230 mm (width / height / length). A total of 9 through holes (a combination of varying speeds and feed rates) were then drilled into the workpiece. In all cases, the drilling process was carried out by means of a standard CNC machine tool (Pinnacle VMC650S) and the standard drills (with a diameter of 3-7 mm, with HSS + Ti coating). In the drilling process, a cycle was applied – flush drilling. The conditions of the cutting process were set as follows: spindle speed  $n$ : 2000, 4000, 6000 rpm, feed rate  $f_n$ : 100, 200, 300 mm.min<sup>-1</sup>. Before measuring the roughness parameters, it was necessary to cut the part along the holes (application of a band saw). Description of the experiment – see Table 2 and Figure 5.

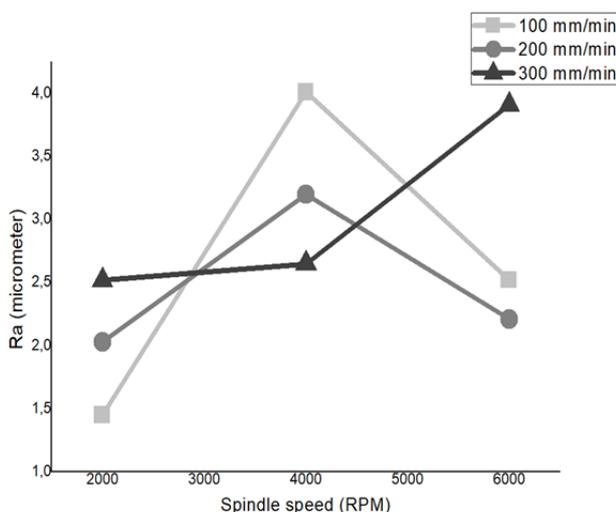
Figure 7. Representation of dependences of surface roughness parameter  $R_a$  in relation to changing: spindle speed

Figure 7 shows the dependence of the mean arithmetic deviation of the unevenness profile  $R_a$  in relation to the changing spindle speed – for a 3 mm diameter drill. At feed rates of 100 and 200 mm.min<sup>-1</sup>, the dependences of the parameter  $R_a$  behave similarly – at a mean speed – 4000 rpm, the  $R_a$  values increase, and then decrease at maximum spindle speed. At a constant feed rate of 300 mm.min<sup>-1</sup>, the dependence tends to behave in opposite directions.

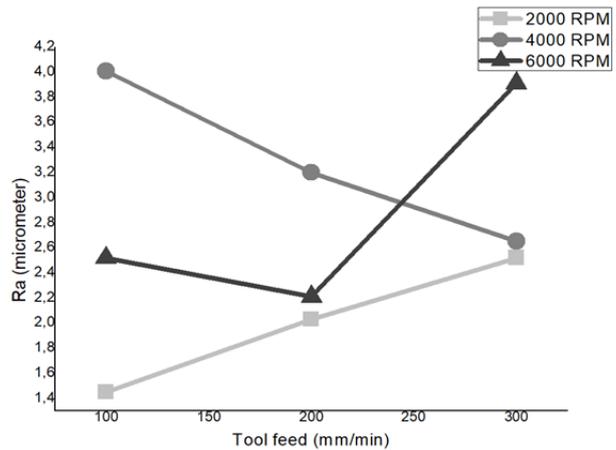
Figure 8. Representation of dependences of surface roughness parameter  $R_a$  in relation to changing: tool feed

Figure 8 shows the dependence of the mean arithmetic deviation of the unevenness profile  $R_a$  in relation to the tool feed – for a 3 mm diameter drill. In the case of maximum and minimum speeds, the dependence of the parameter  $R_a$  in relation to the changing tool feed has an increasing tendency. The decreasing tendency is visible at medium spindle speed – 4000 rpm. The value of the surface roughness parameter decreases from 4.01  $\mu\text{m}$  (at a feed rate of 100 mm.min<sup>-1</sup>) to 2.21  $\mu\text{m}$  (at a feed rate of 300 mm.min<sup>-1</sup>). This makes a difference of 1.8  $\mu\text{m}$ .

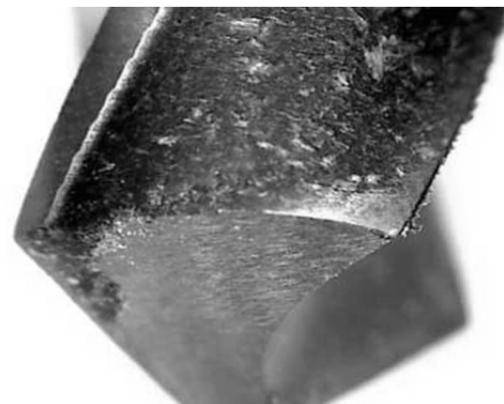
Figure 9. HSS twist drill – with coating (stick material to drill groove) [15]

Macroscopic evaluation of the created holes / tools: when drilling with TiN-coated HSS twist drills, the cross-sectional surface has the shape according to Figure 9. The surface of the hole has a "shiny" character (compared to the part of the material divided by a band saw). The shiny nature of the surface was caused by the melting of the plastic matrix of the material – during the passage of the tool. The surfaces after the cuts have regular shapes (there were no irregularities in the traces of the cutting part of the screw drill). Holes dark areas are visible on the surface of the holes. Dark areas were created as a result of the uneven structure of the composite material (the material has different character in different parts – it is inhomogeneous). In the process of drilling there was a so-called delamination – damage to the surface layer of material near the hole. When drilling with a tool with a small diameter (3 mm), the chip was not removed from the tool groove – which caused the material to melt and subsequently stick to the drill groove (Figure 9). This phenomenon did not occur with larger drill diameters. With a 7 mm diameter drill, the sticking of molten plastic on the secondary back surface of the drill is visible.
